## PRESERVING YORK HALL

# The Hidden Value of a Deeper Structural Understanding

*For many existing buildings, a targeted and more cost effective solution can be found through the use of advanced nonlinear analysis procedures.*

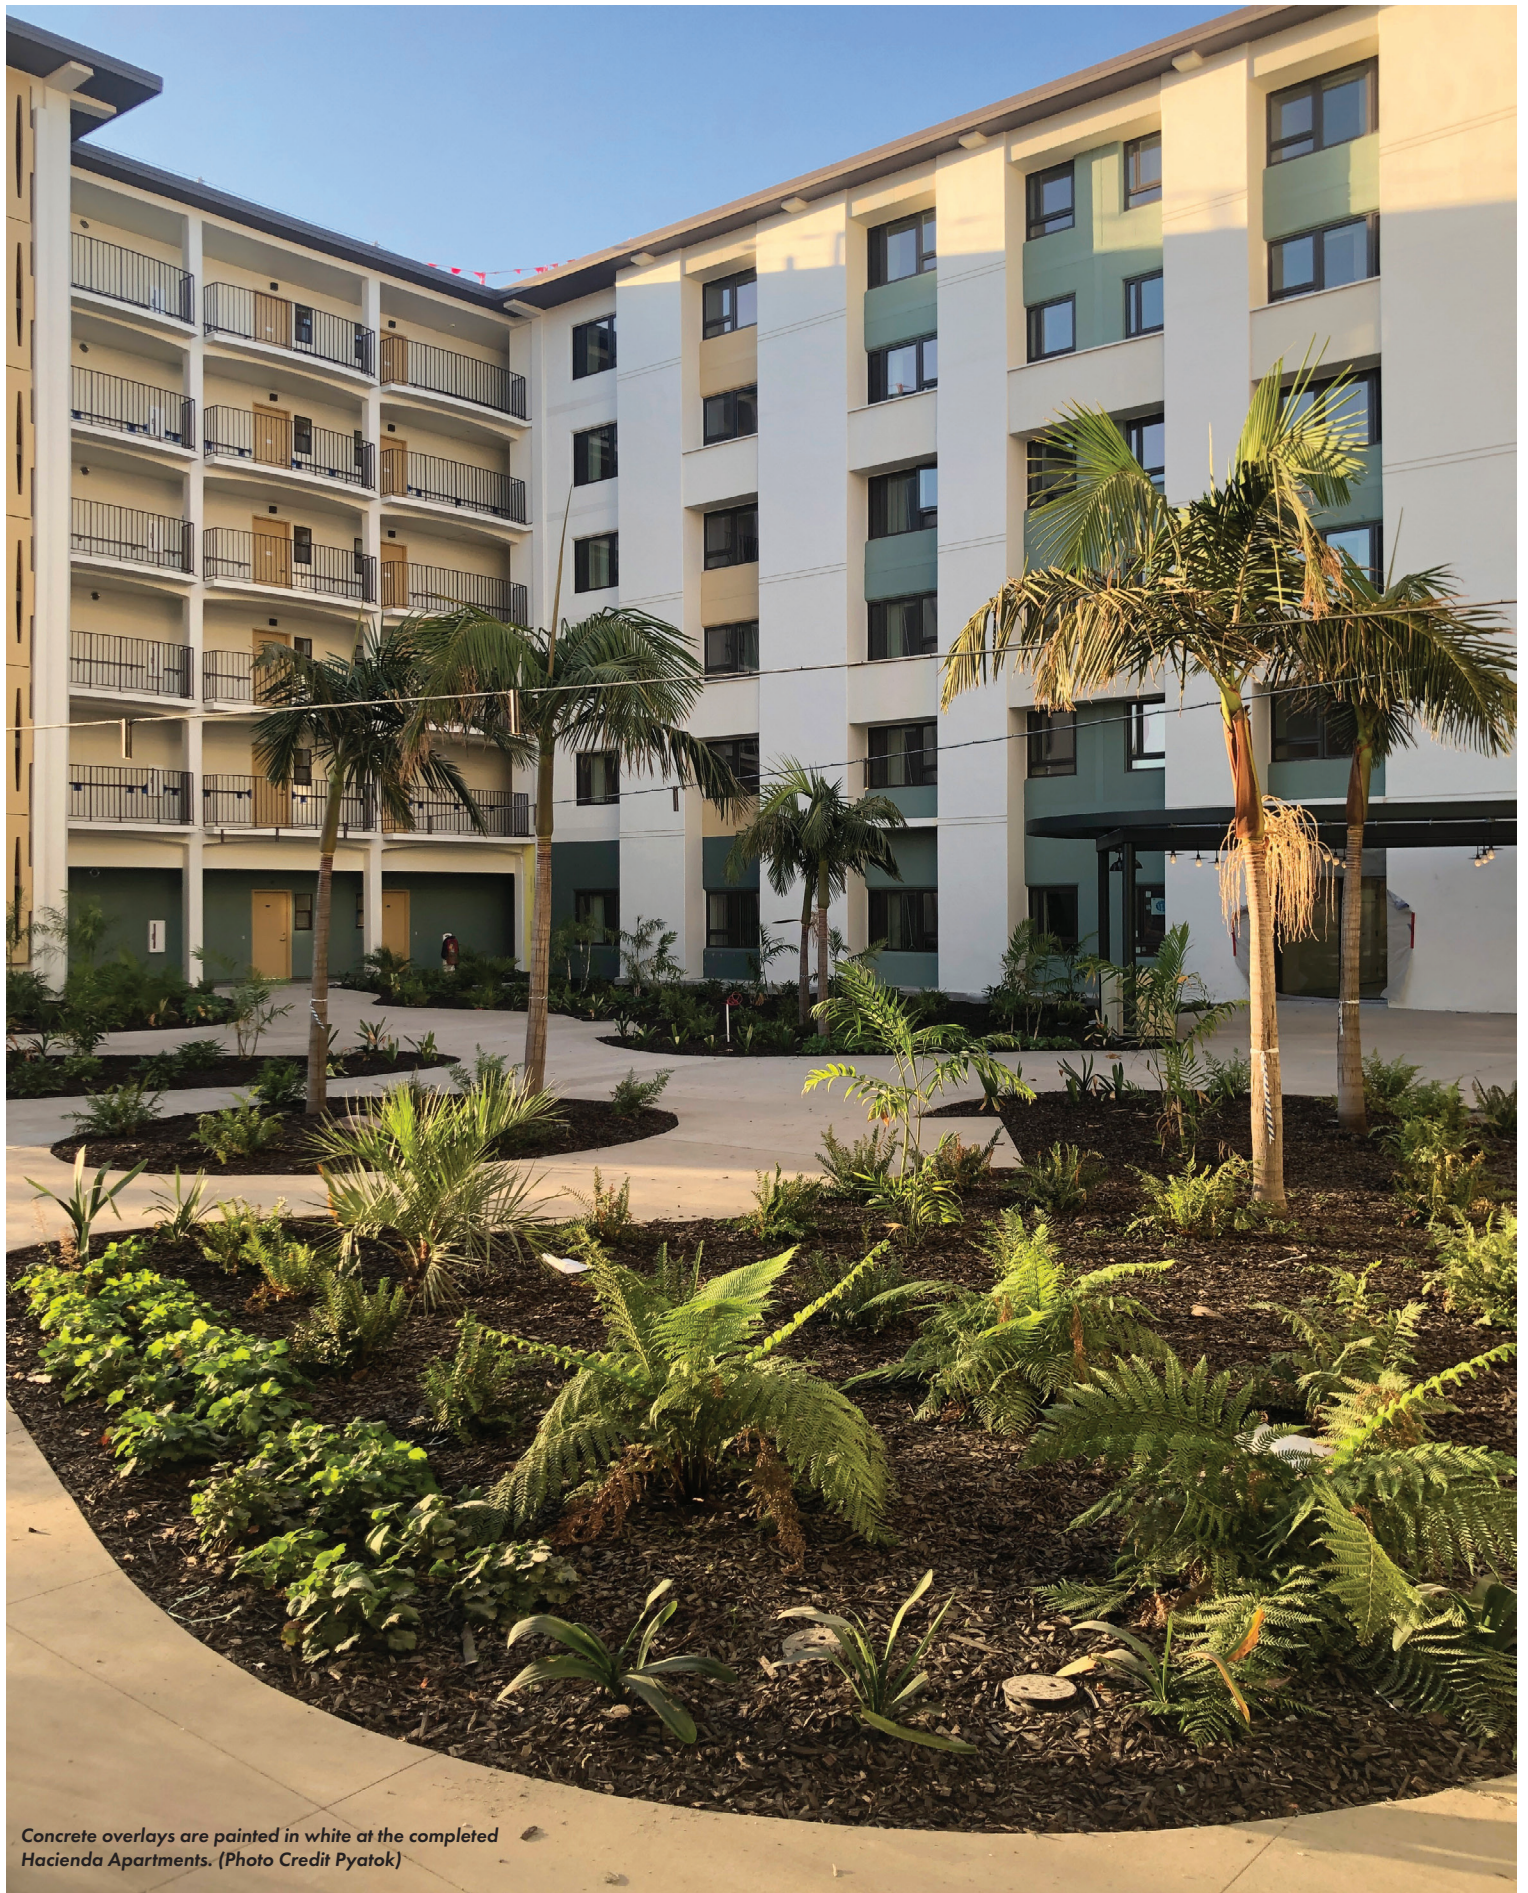
Concrete overlays are painted in white at the completed Hacienda Apartments. (Photo Credit Pyatok)

link to make the buildings behave as one large building. To limit the stress on the existing walls, six 15-inch by 24-foot planar walls and four 24-inch by 50-foot shotcrete panels were overlaid to the existing wall to reduce the demand capacity ratios (DCRs) on the existing walls to the ASCE-41 acceptance criteria. The new walls were supported by large spread footings to ensure the soil bearing was acceptable.

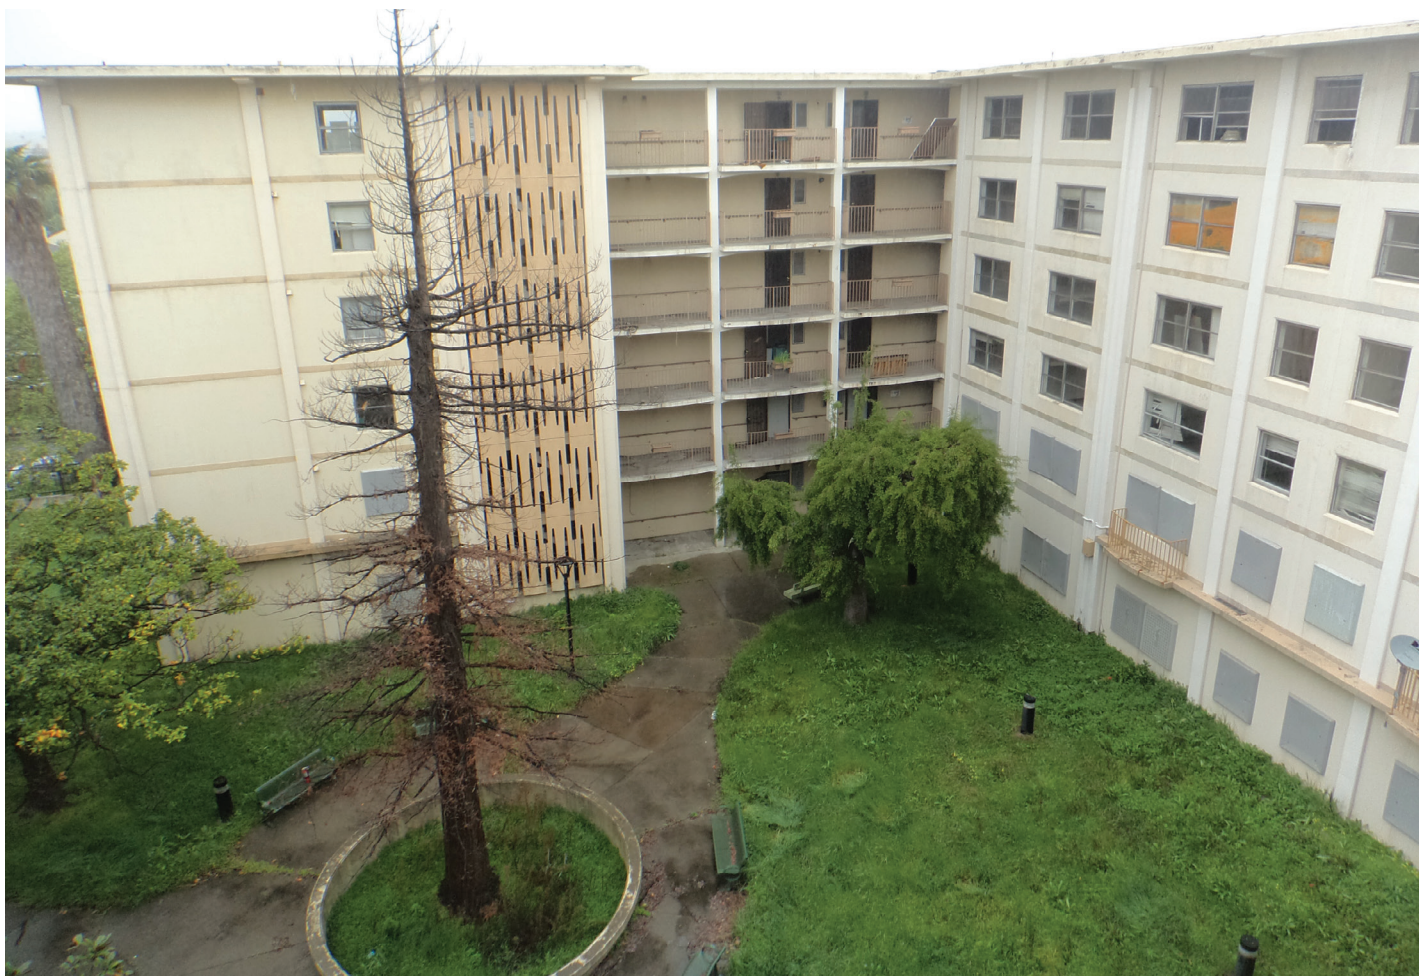
The Hacienda Apartments is a 150-unit complex built in 1964, before modern seismic building codes were developed. (Photo Credit Pyatok)

The Hacienda Apartments is a 150-unit, 121,000 square-foot complex that served as low income senior housing for decades, but became severely deteriorated due to neglect. The complex consists of four structurally independent six-story, mild steel reinforced non-ductile concrete structures built in 1964, before modern seismic building codes were developed. Each building is rectangular in plan and configured to have an open-air walkway on one side and concrete walls on the other three.

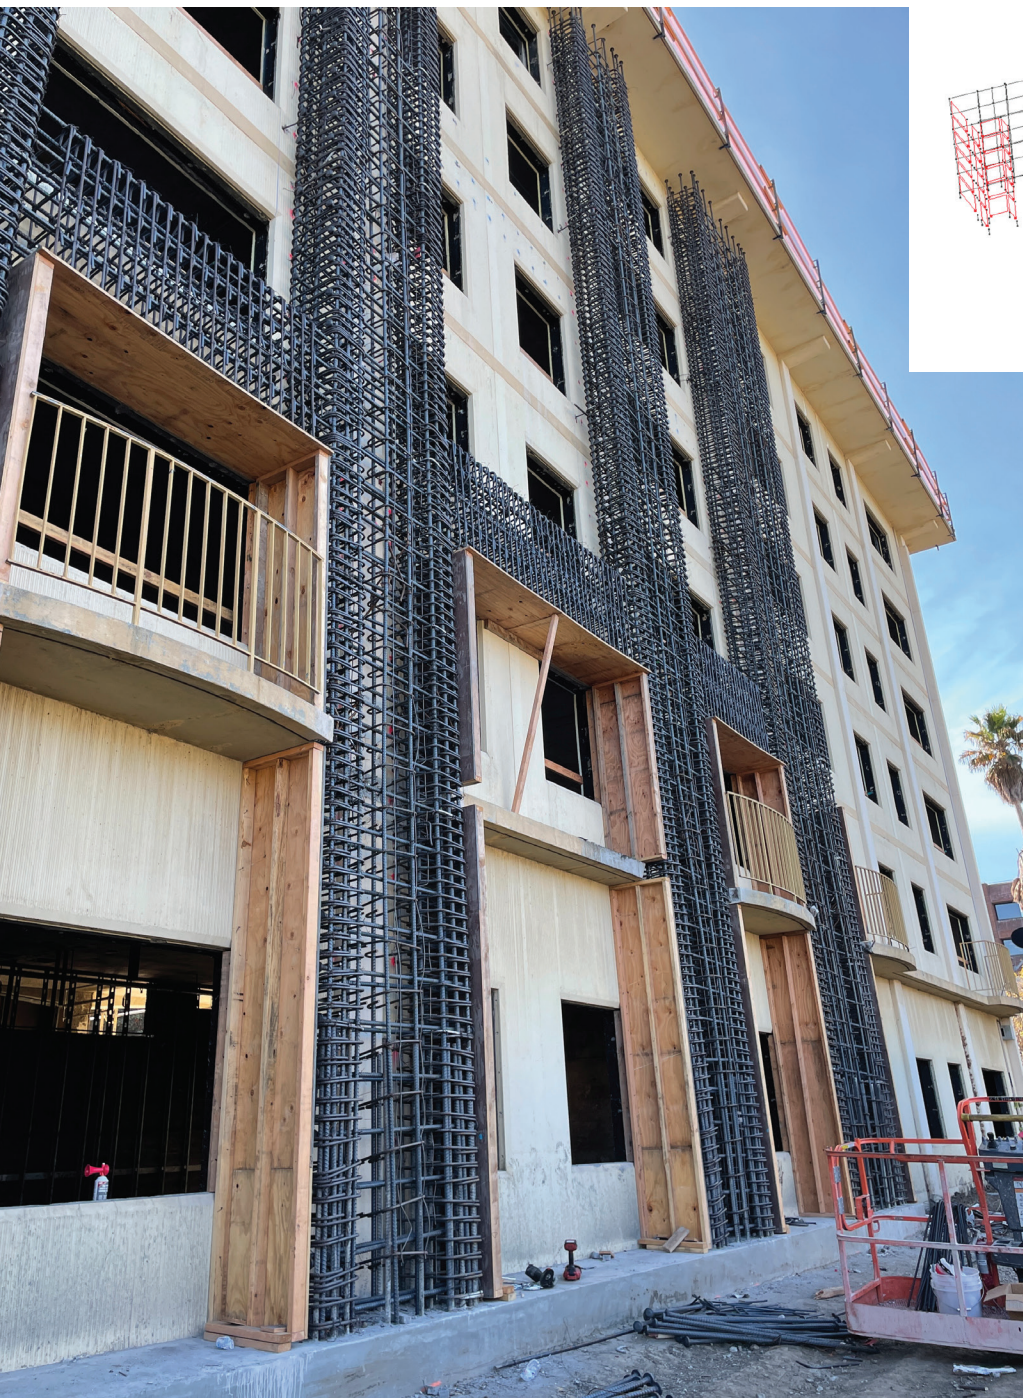
Top right: The nonlinear dynamic analysis model provided critical insight into the structure behavior. This approach eliminated the need for collectors at five of six floors, five new full height shear walls, and micropile deep foundations.

It was at this point that a nonlinear dynamic procedure (NDP) was leveraged to explore the possibility using insight from the more detailed approach to optimize the design and reduce the cost of the seismic improvements. A Perform 3D model was set up with all lateral elements modeled inelastically. Pier and spandrel elements represented the perforated walls with shear hinges, flexural hinges at the spandrels, and fiber section at the piers. The walls used inelastic shear and flexural elements. Additionally, inelastic collector elements and gap hook elements at the building joints were used to monitor the seismic joint. Existing and new foundations leverage soil springs to model soil yielding. All element and material properties used ASCE-41 recommendations and 11 ground motions were selected and scaled to match the target spectrum for the site.
